Purpose

Site specific field evaluation of proposed stands for commercial timber harvest, and the soil mapping units occurring at the stand level.

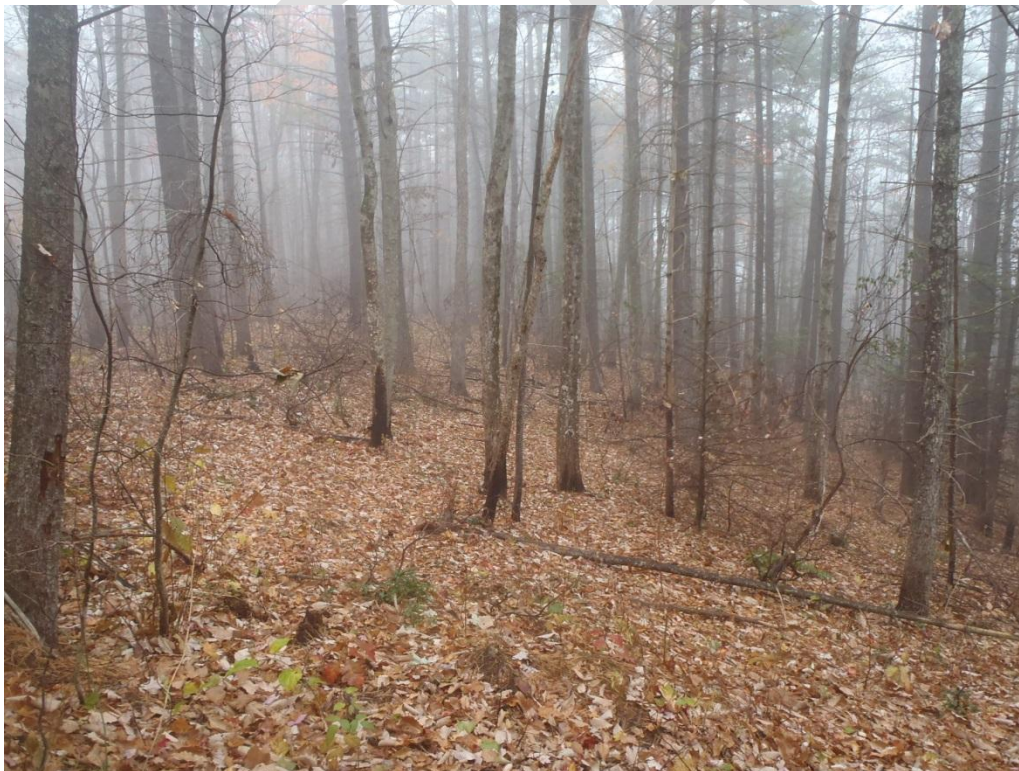
Most of the area mapped as Junaluska-Brasstown "F" slopes is actually dominated by "E" slopes with intermittent spots that may exceed 35%.

Figure 1. Looking north along ridge mapped as Junaluska-Brasstown "F" in 217/10

One steep area on the NE corner of the stand may be harvested by cabling trees up slope. There would be no roads placed in this steep section. Much of the area mapped as Northcove "F" slopes would be excluded from harvesting activities because it is in the riparian area.

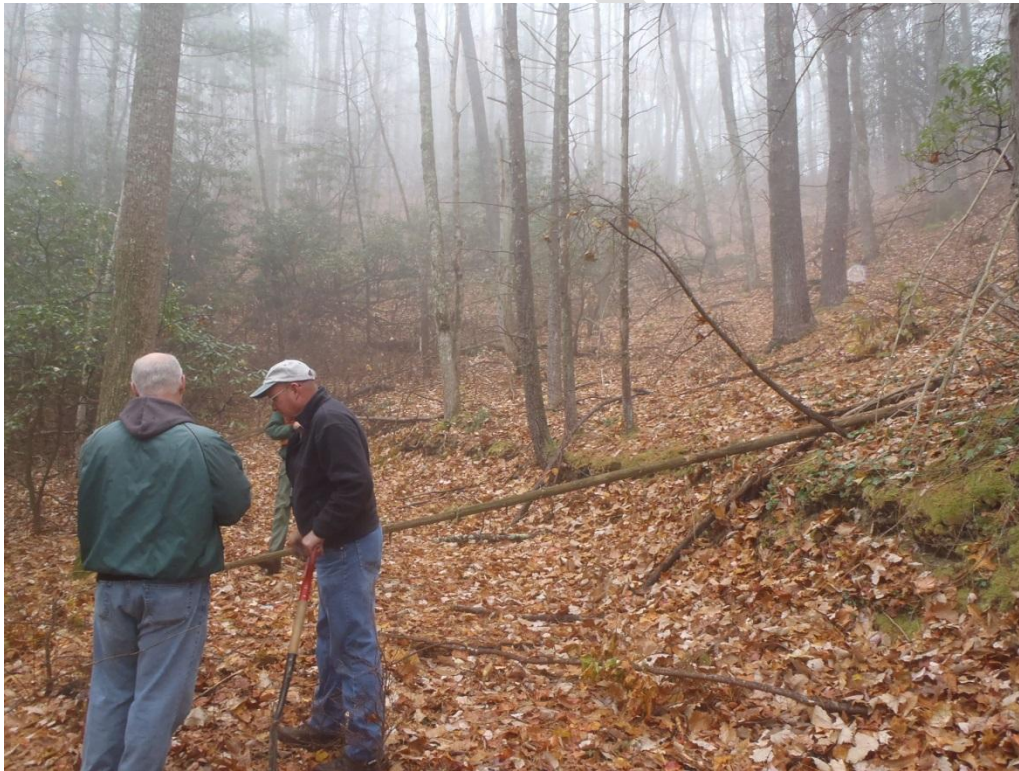
Much of the eastern portion of this stand is mapped as Junaluska-Brasstown "F" slopes. During the field review we found that the area has both "E" and "F" slopes. During the field review we found old roads in this stand that are vegetated and have remained stable for many years with no evidence of slipping or slumping. Tree form in the unit also indicates that the soil is generally stable both upslope and downslope from the old road. Based on this field investigation the stand was determined appropriate for proposed harvest operations.

Figure 2. Old road through 217/31. Area mapped as Junaluska-Brasstown "F".

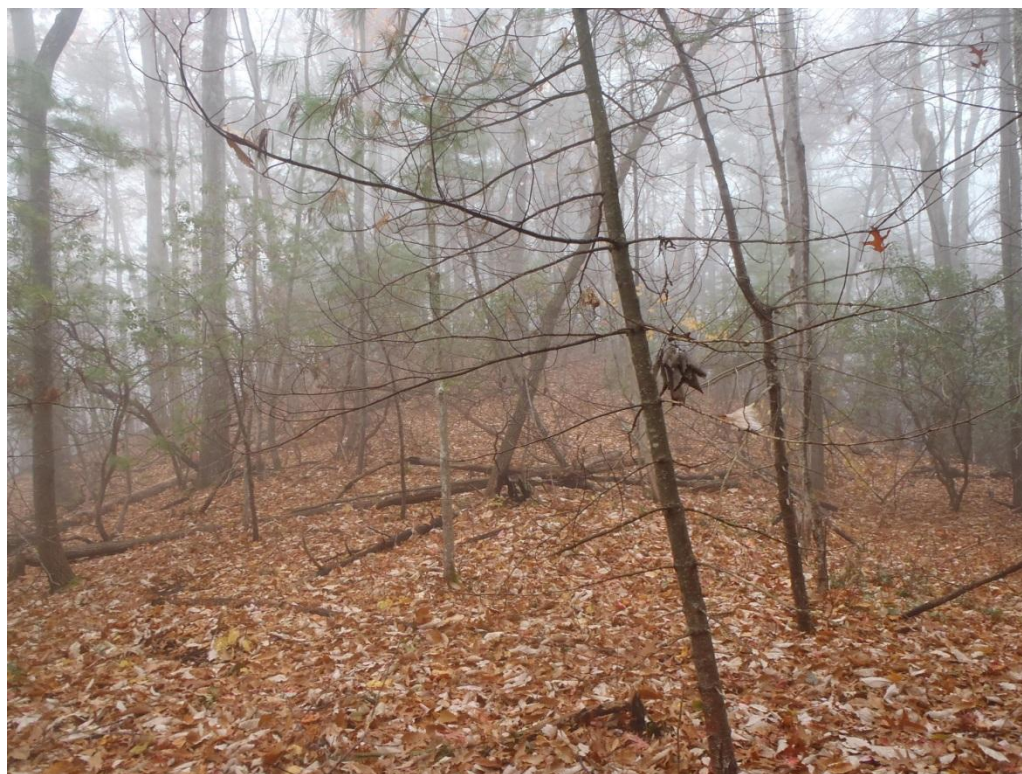
Figure 3. Ridge mapped as Junaluska-Brasstown "E" in 217/31. The dominant grade on the area of this ridge proposed for management is less than 20%.

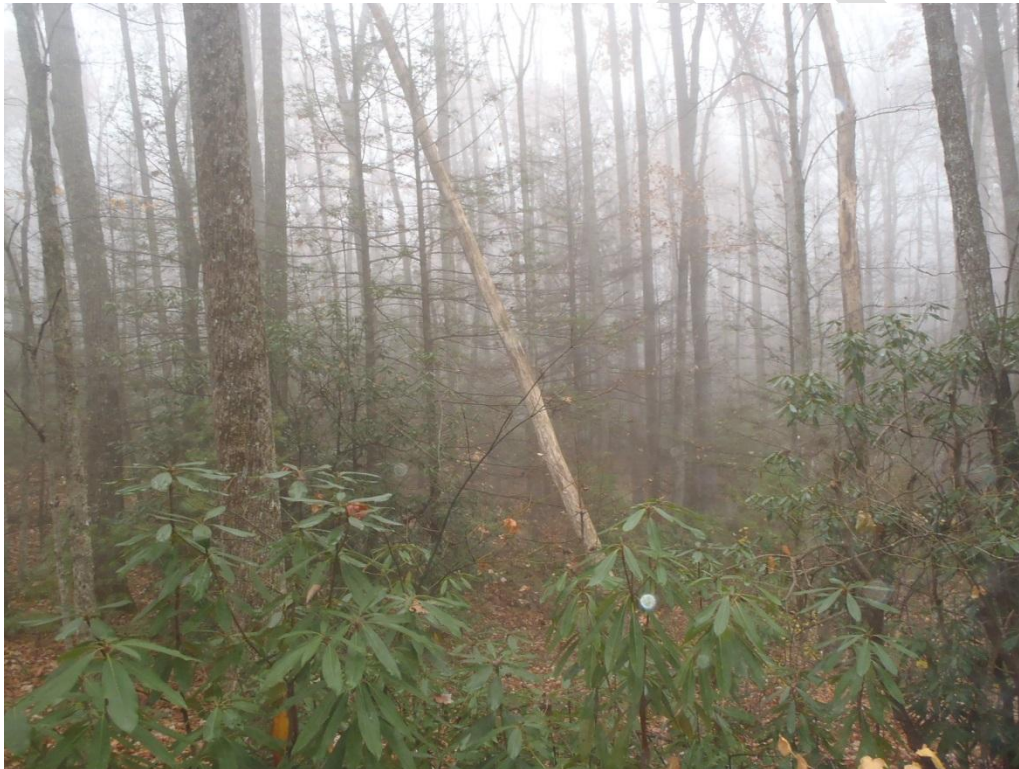
Although mapped as a G slope (50-80%), this stand also has soil mapping unit components identified in C, D, E and F slope groups. The majority of the stand in the northwest quadrant has both E and F slope, with most being E slope gradient, or 20-35%.

Figure 4. Looking northwest into 215/46 along ridgeline mapped as Brasstown "G", however the ridge crest and upper slopes are lower gradient than Brasstown G as mapped.

Steeper sections in this portion of the stand would be accessed from the ridge tops and cables would be used to cable trees up slope.

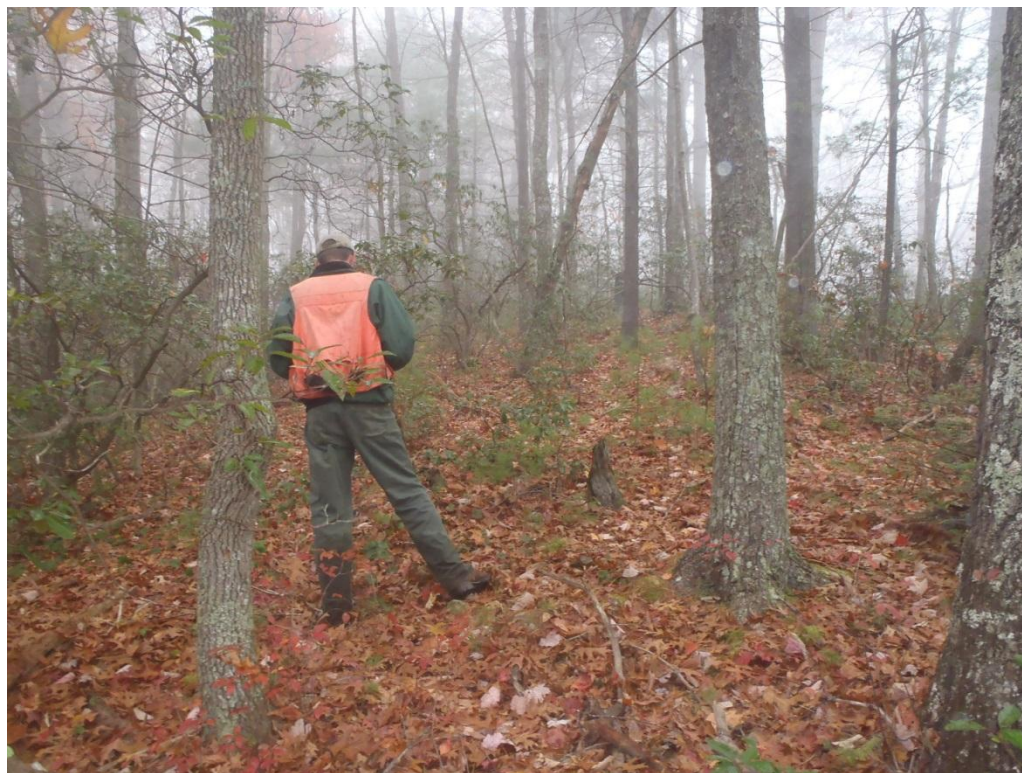
Figure 5. Looking upgradient along northernmost ridge in 216/2. Area mapped as Junaluska-Brasstown "F".

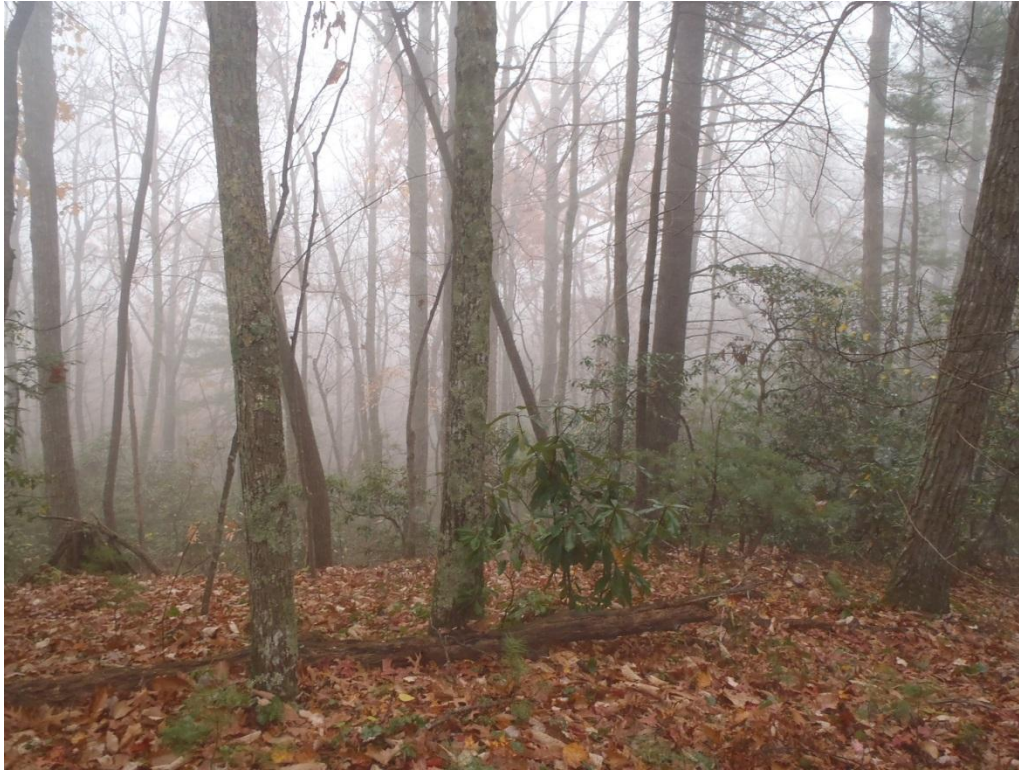
Figure 6. In 216/2, no ground-based equipment operation will occur on steep side-slope descending away from ridge towards road. Further than 65'-75' from ridge crest the ground is too steep for ground based equipment. Some limited cabling may occur. Area mapped as Junaluska-Brasstown "F".

The steeper sections would be accessed from above and a cable would be used to move the harvested trees upslope to flatter areas. No additional design criteria needed in this stand due to the prevalence of lesser slopes.

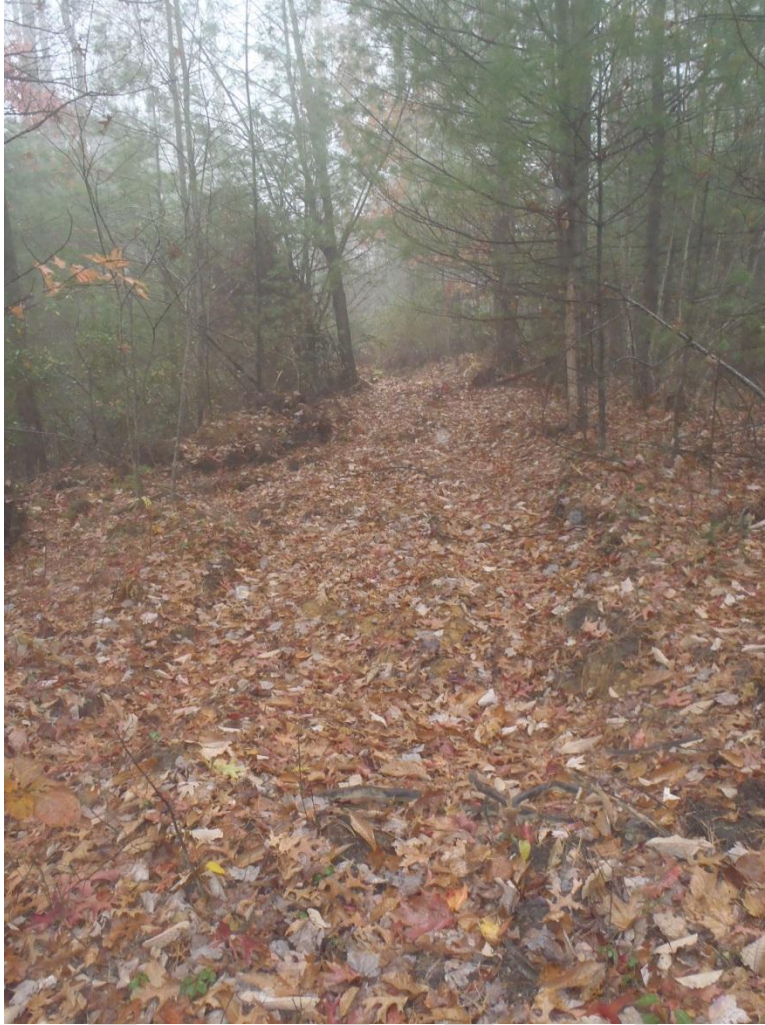
Figure 7. Existing Dozer Line in 216/2. Area mapped as Junaluska-Brasstown "D".

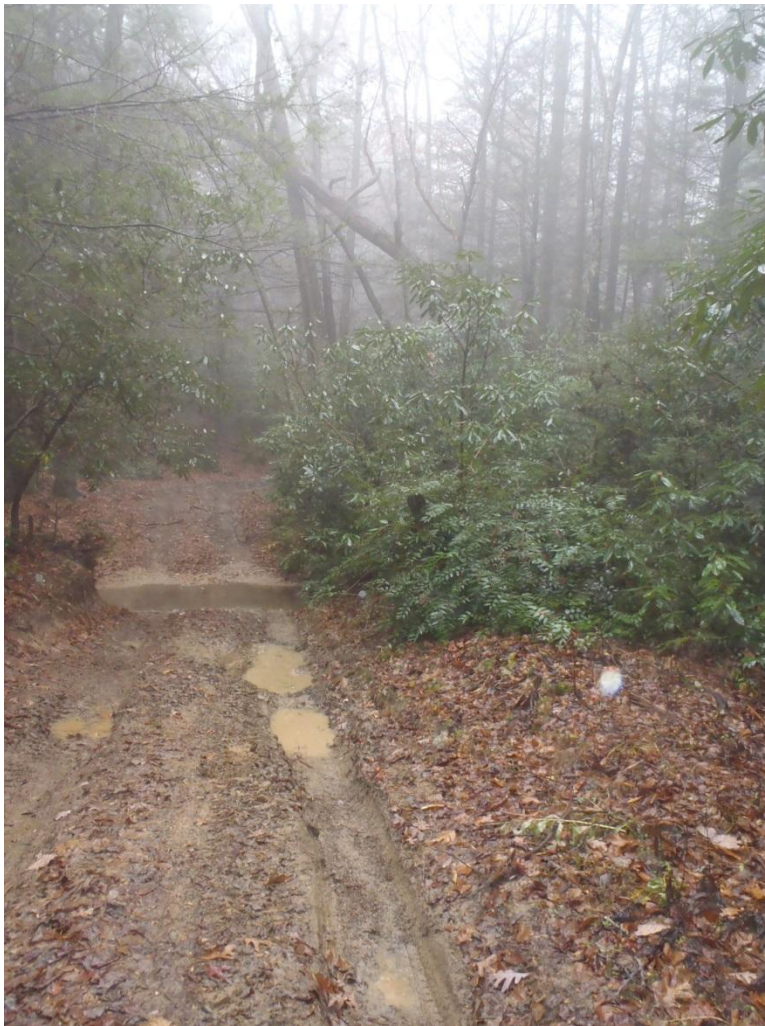
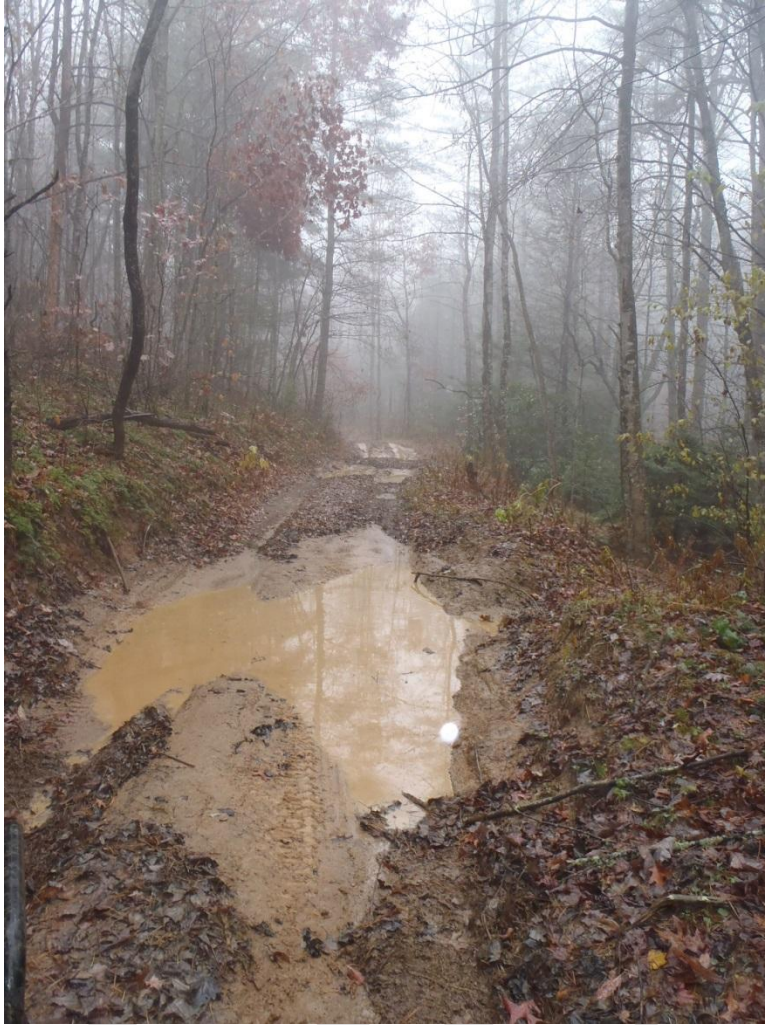
The second day of fieldwork focused on stands in the Devil's Kitchen area. There are several old roads in this area. Old roads are generally stable, except where unauthorized use is occurring. Roads that are receiving frequent unauthorized use are being eroded and/or compacted, and need to be reshaped and/or decommissioned. Implementation of the proposed project would aid in stabilizing these road issues. Road condition photos are presented in figures 8 and 9, below.

Figure 8. FSR 93. Area mapped as Northcove "E".

Figure 9. FSR 93. Area mapped as Northcove "E".

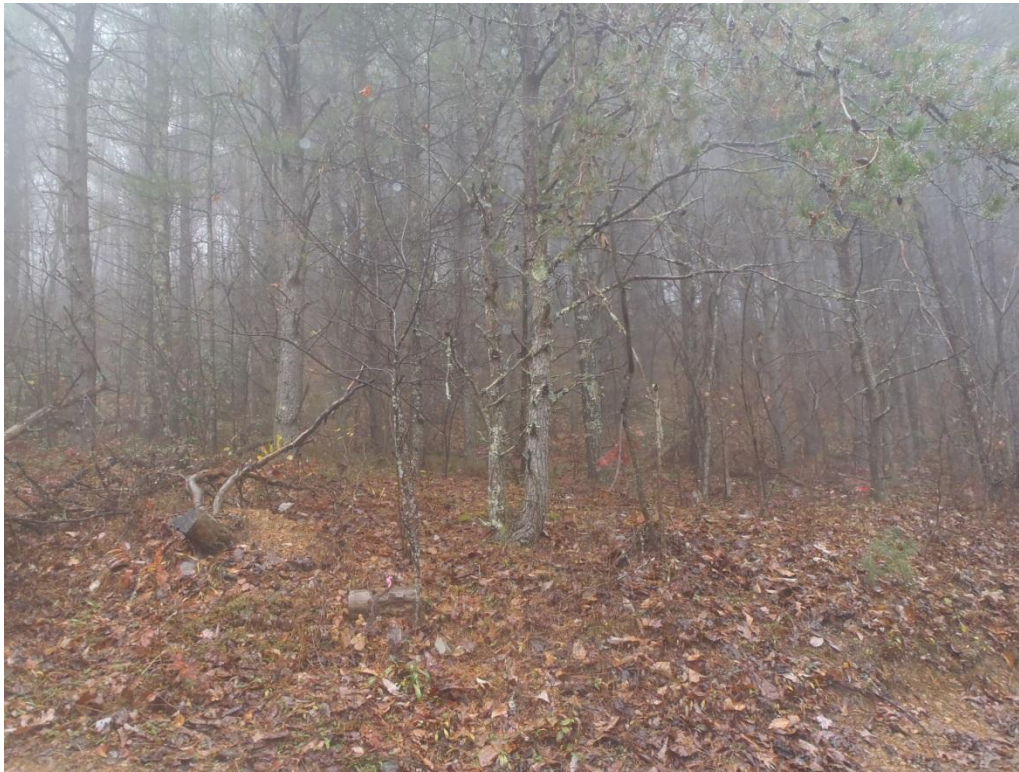
Mapped as "E" slopes, field visit validated this mapping.

Figure 10. Looking east into area of 209/1 mapped as Junaluska-Brasstown "E".

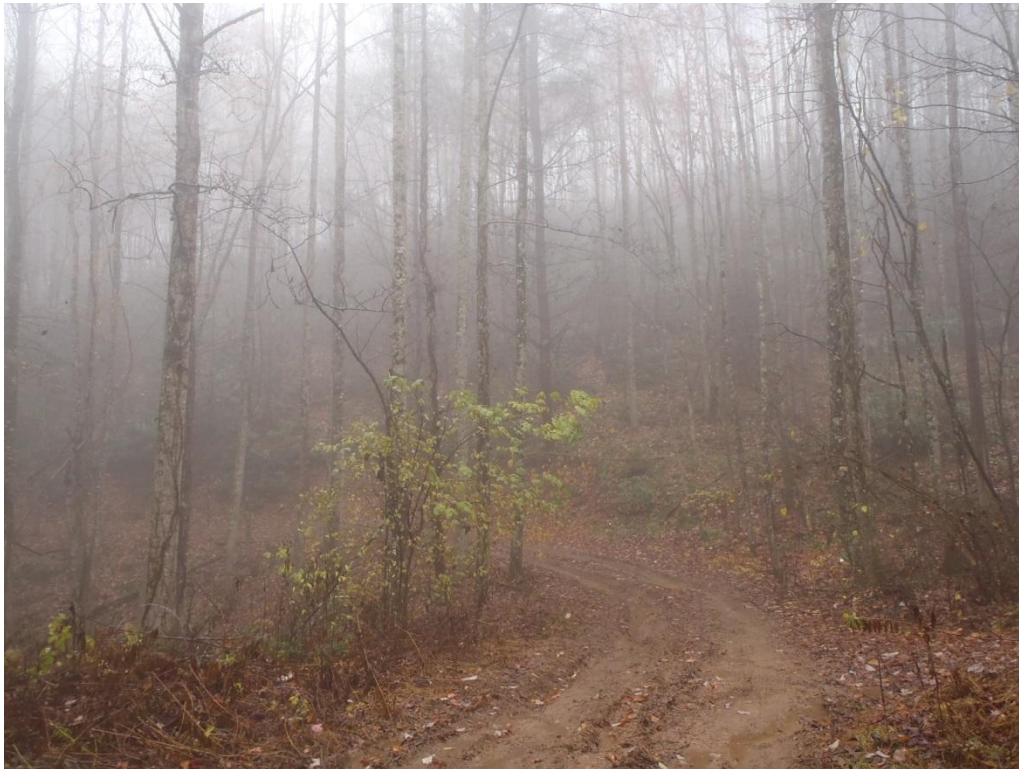
Mapped as "F" slopes. Some steeper areas are present. Field visit validated mapping.

Figure 11. View of 209/4 in background. Looking southwest along FSR 93. Area mapped as Junaluska-Brasstown "F" slope.

Ground based equipment will be restricted to appropriate areas as specified in the design criteria in the EA and this document.

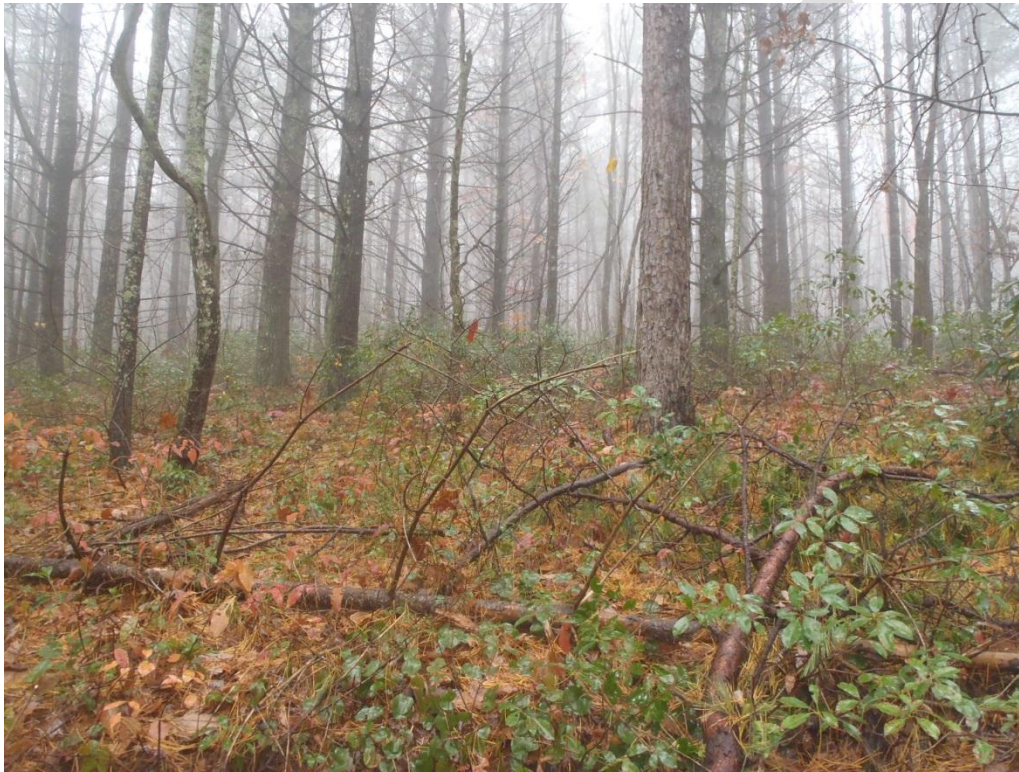
Mapped as “F” slopes. Field visit found that most of the area proposed for management actually has “D” and “E” slopes with intermittent “F” slopes toward the upper side of the ridge.

Figure 12. View northwest into 209/3 from FSR 93. Area mapped as Junaluska-Brasstown “F”.

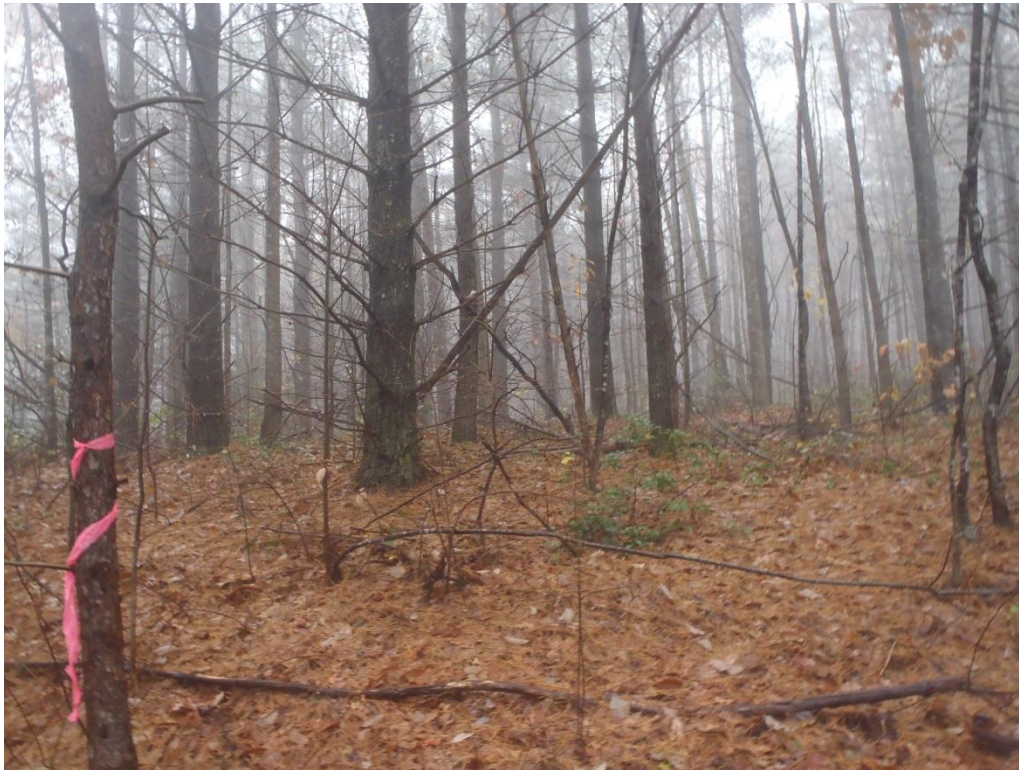
Mapped as "F" slopes. Field visit found that most of the area proposed for management actually has "D" and "E" slopes with intermittent "F" slopes.

Figure 13. View east into 209/21 from northwestern corner of unit. Area mapped as Junaluska-Brasstown "F".

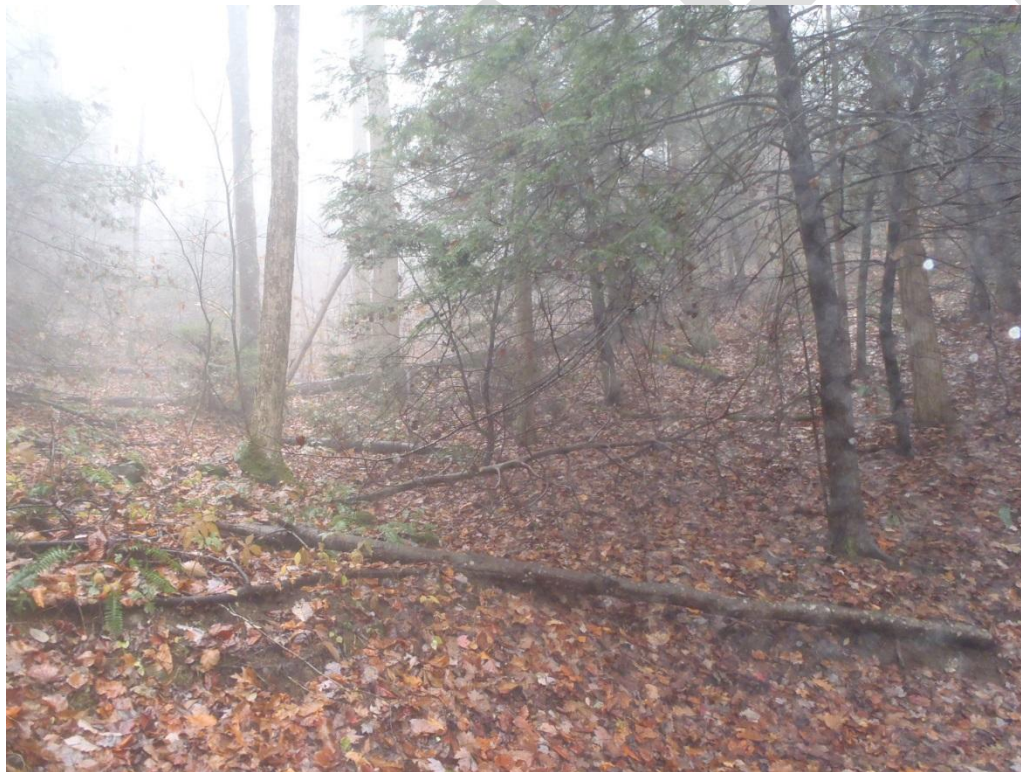
There are areas in this stand that are mapped as having "G" slopes. Portions of these areas are within the upper range of "F" slopes. There are slopes exceeding 50% in this stand and a few isolated areas that appear to have unstable soil conditions in the steep sections.

Figure 14. View south into 209/30 from FSR 93. Area mapped as Unicoi Rock Outcrop. Some signs of localized soil instability present in this area.

Special precautions should be used to avoid these areas with heavy equipment and bench-cut roads during implementation. A forest hydrologist and/or soil scientist should review layout, implementation, and rehab of this stand. These concerns are only for the steep sections and unstable areas of the stand. No constraints would be needed for the portions of the stand that have "E" slopes.

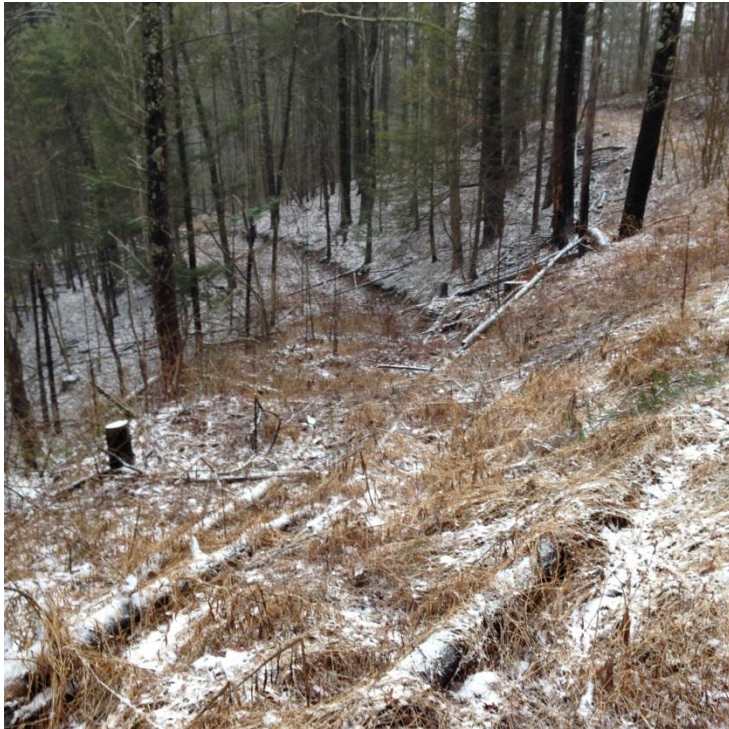
Figure 15. Skid Road used in 2009 Sale. Area mapped as Junaluska-Brasstown "F" (35-50% slopes). Waterbars are functioning and road is fully revegetated.

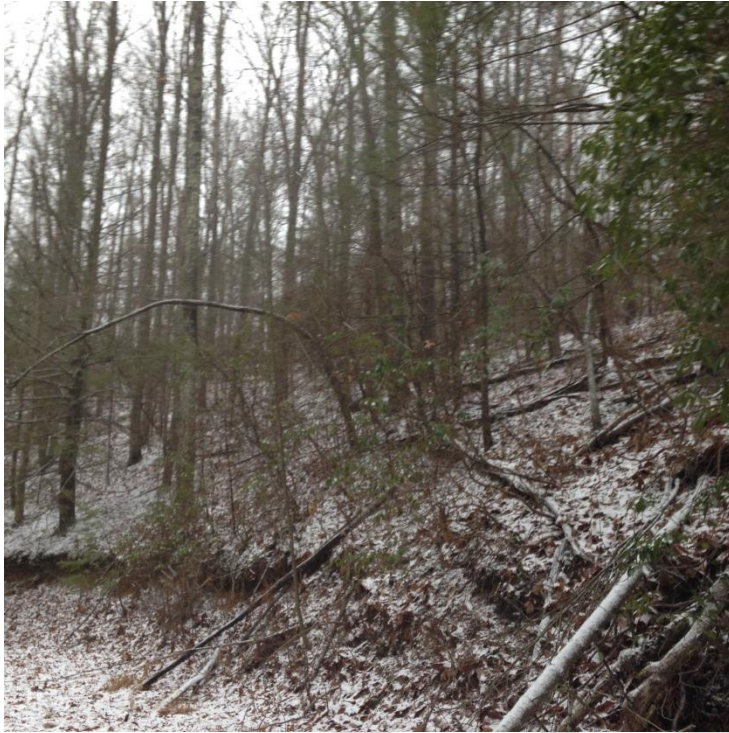
Figure 16. Ridge above system road was logged without construction of a mid-slope skid road in 2009. Proposed sale would be executed with a similar layout. Area mapped as Junaluska-Brasstown "F".

Above the road, no mid-slope skid road will be constructed. All timber will be brought up to a skid road at the top of the ridge or down to the existing road. The 2009 timber sale adjacent to this proposed unit was implemented this way without issue. See photos 15-17.

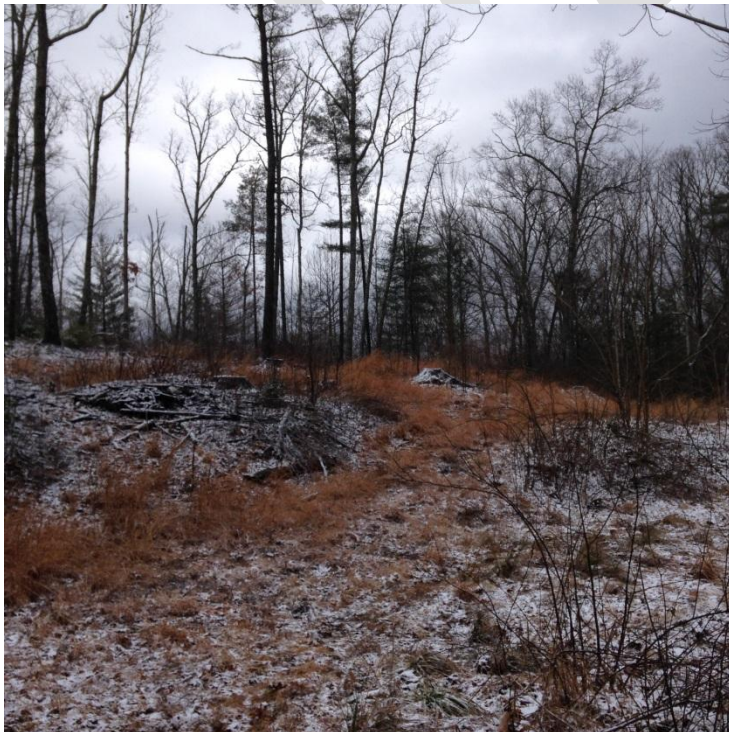
Figure 17. Landing used for 2009 sale is stable and fully revegetated. Area mapped as Junaluska-Brasstown "D".

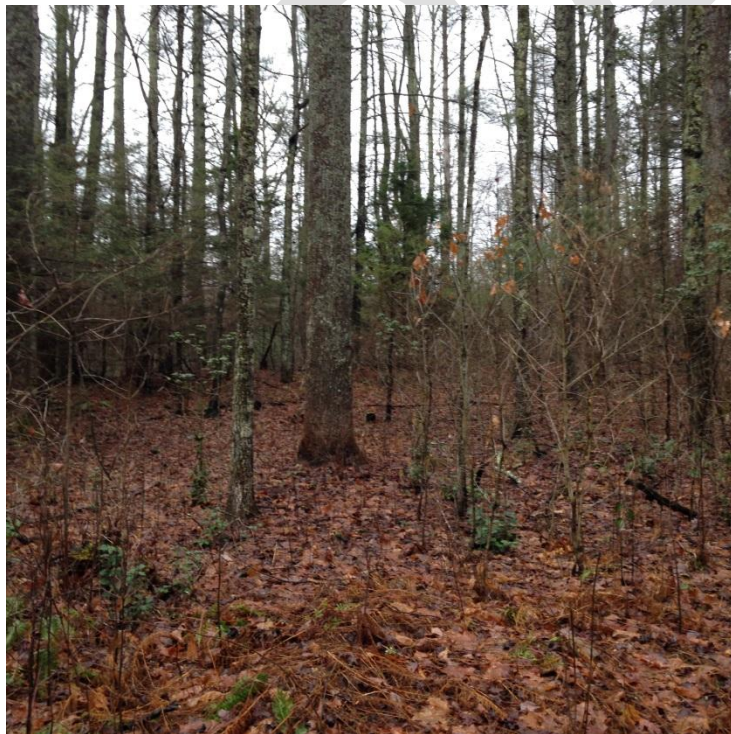
Figure 18. Looking southeast into 216/25 from Courtland Place. Area mapped as Brasstown “C”.

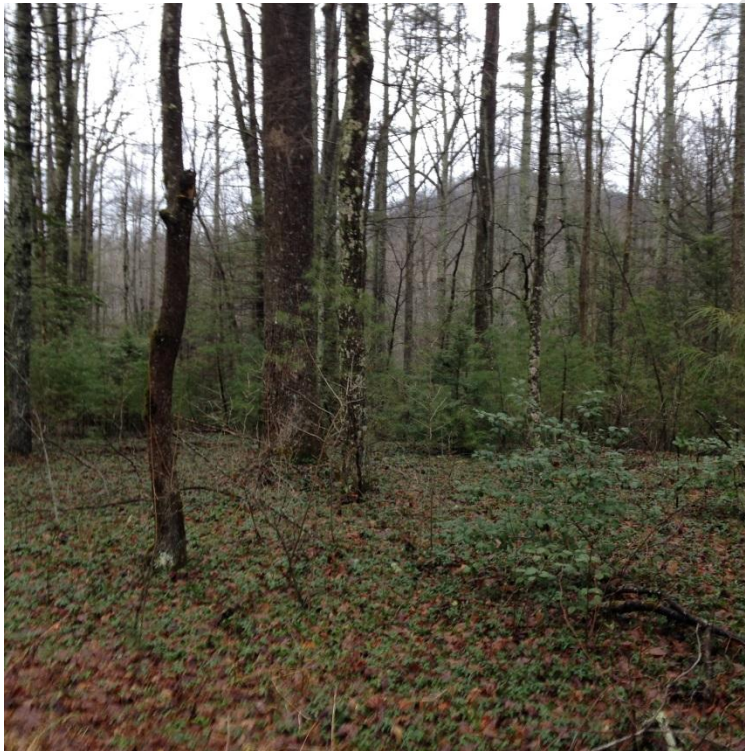
These stands are very flat. The majority of the stands have slopes less than 5%. The small area mapped as Junaluska-Brasstown F will be excluded because it is within the riparian buffer.

Figure 19. Looking north into 215/22 and 215/53 from edge of wildlife field across from Courtland Place. Area mapped as Brasstown "C".

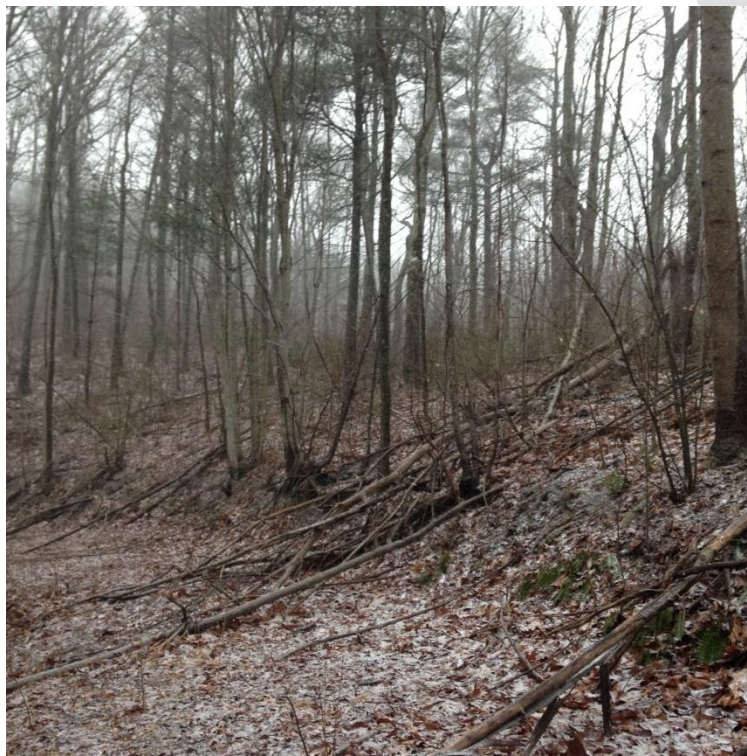
This stand is accurately mapped as being dominated by “F” slopes. On site measurements indicate that the average grade is approximately 45% - 50%. Pistol butted trees indicate the occurrence of soil creep both above and below the road.

Figure 20. Western corner of 215/47. Area mapped as Junaluska-Brasstown “F”.

Drainage features on skid roads could cause erosion issues on these steep slopes. Non-commercial treatment may be a more appropriate option for this stand.

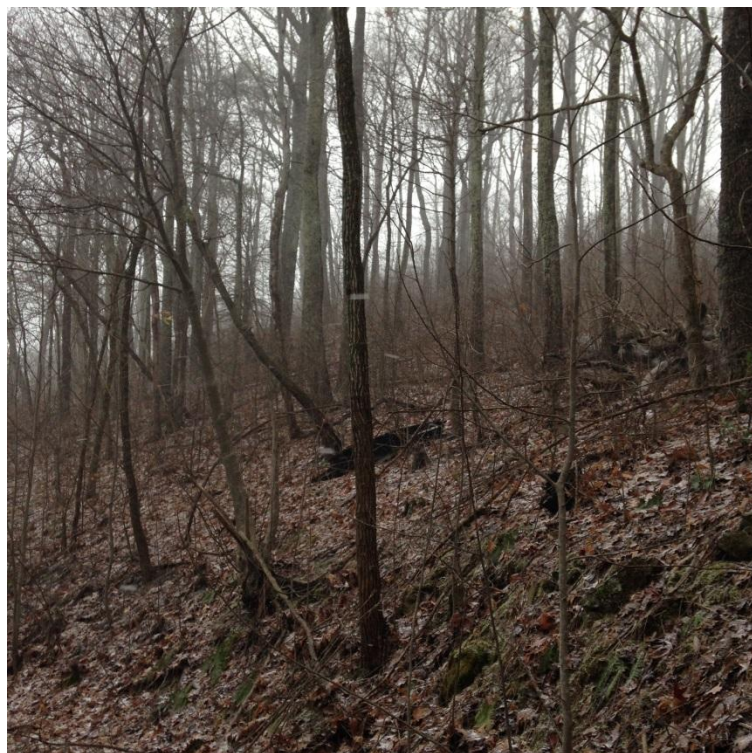
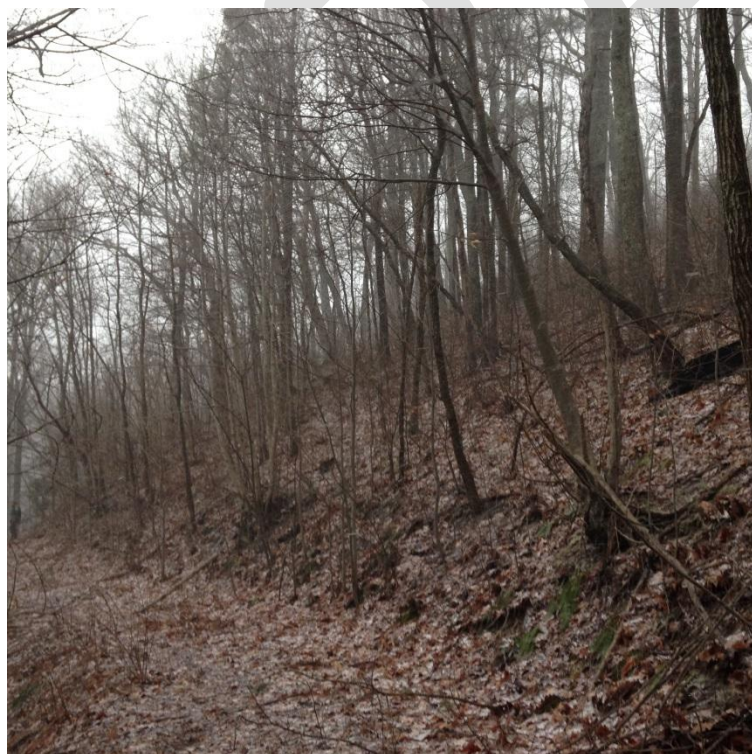
Figure 21. Western side of main ridge in 215/47. Area mapped as Junaluska-Brasstown "F".

Figure 22. Western side of main ridge in 215/47 (wider view). Area mapped as Junaluska-Brasstown "F".

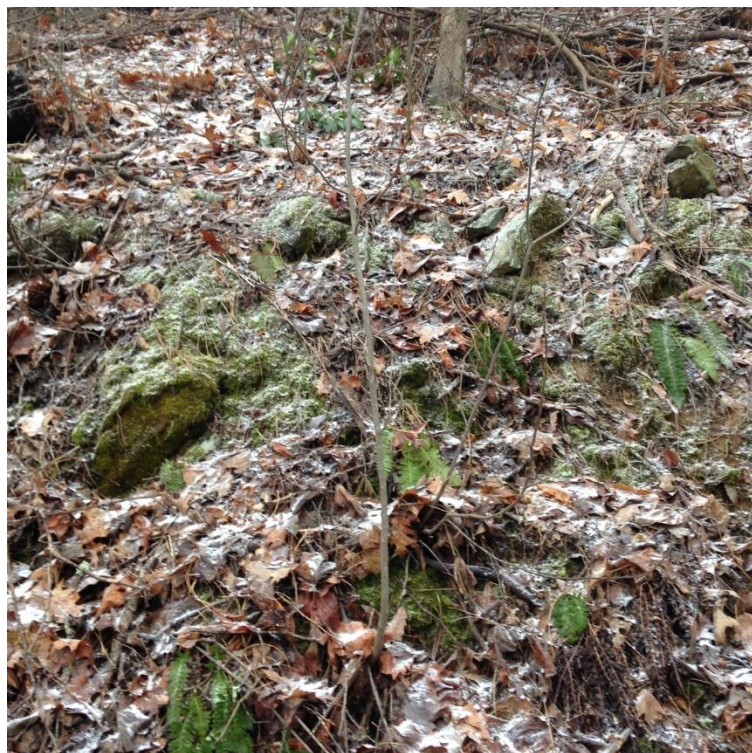
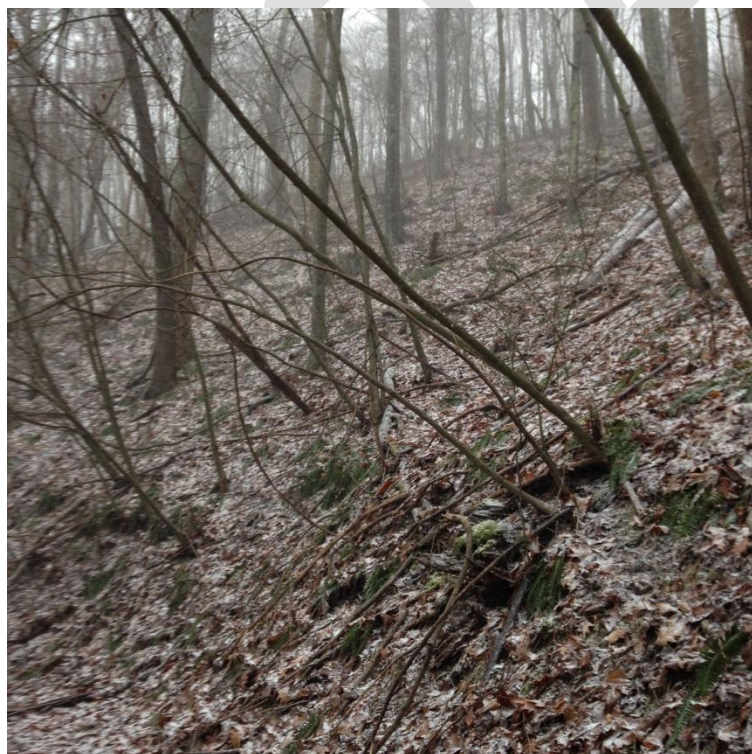
Figure 23. Cut slope of road forming lower boundary of 215/47. Area mapped as Junaluska-Brasstown "F".

Figure 24. Cut slope of road forming lower boundary of 215/47 (wider view). Area mapped as Junaluska-Brasstown "F".

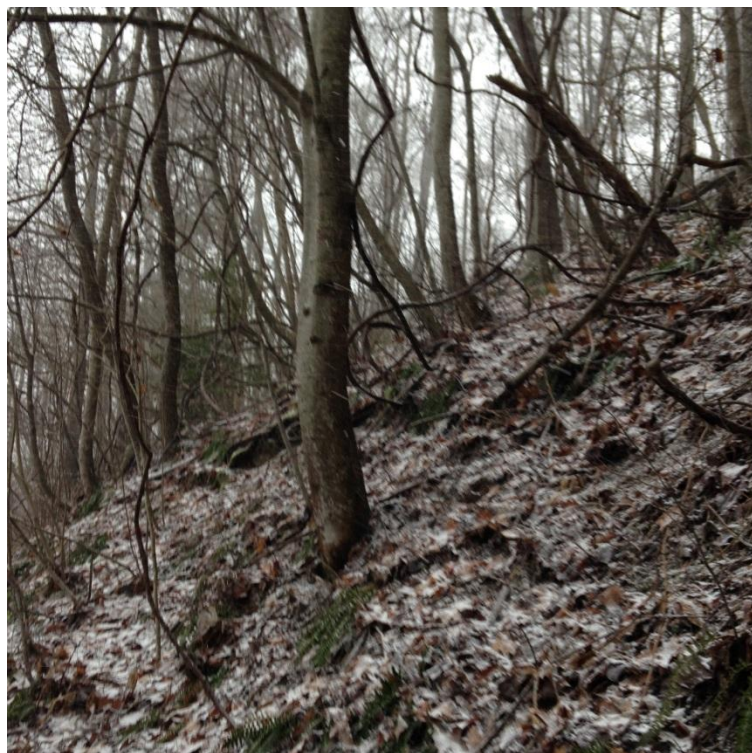
Figure 25. Pistol butted trees indicate soil creep. Area mapped as Junaluska-Brasstown "F".

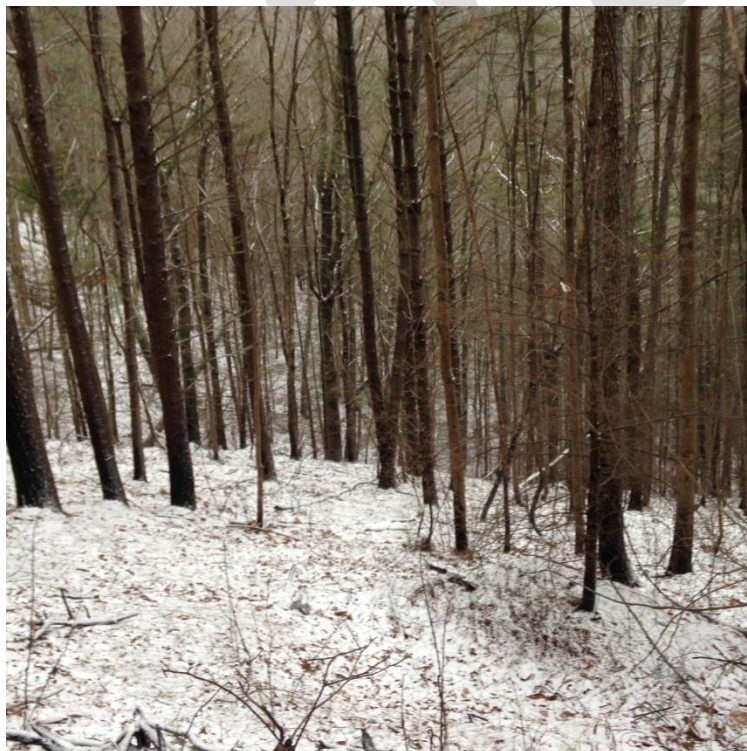
Figure 26. Looking downslope from road across 35% ridge just west of larger of the two areas mapped as Northcove F. Ridge mapped as Junaluska-Brasstown Complex F. Equipment will operate on the ridge as far as the slope break into the drainage (where slopes exceed 55%). Beyond that, timber may be cabled up to the ridge or the road.

Below the road, ground based equipment shall be excluded from slopes in excess of 45% in accordance with project design criteria. Logs may be cabled up to ridges or to the road. No timber harvest will occur on areas mapped as Northcove F.

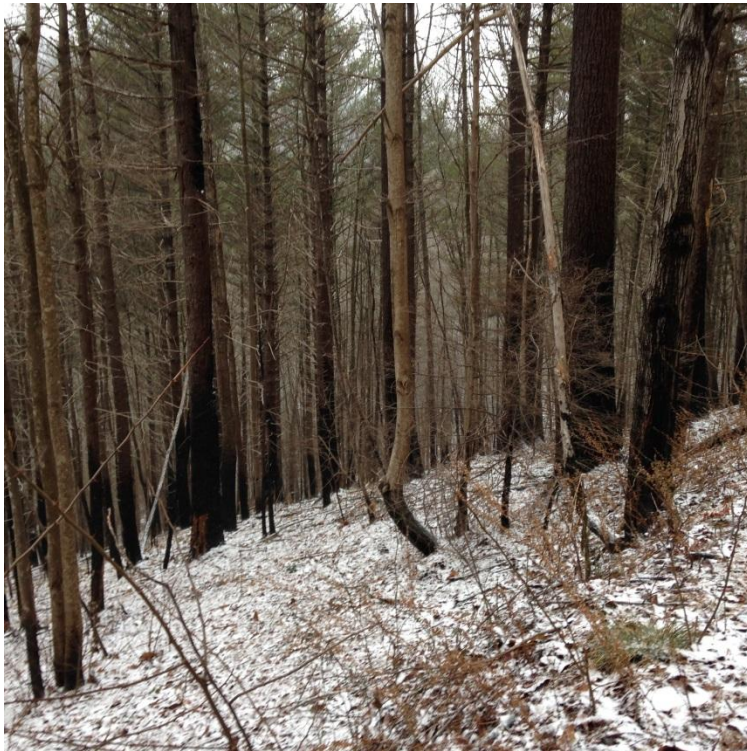
Figure 27. Pistol butted tress below the road may indicate some soil creep. Area mapped as Junaluska-Brasstown "F".

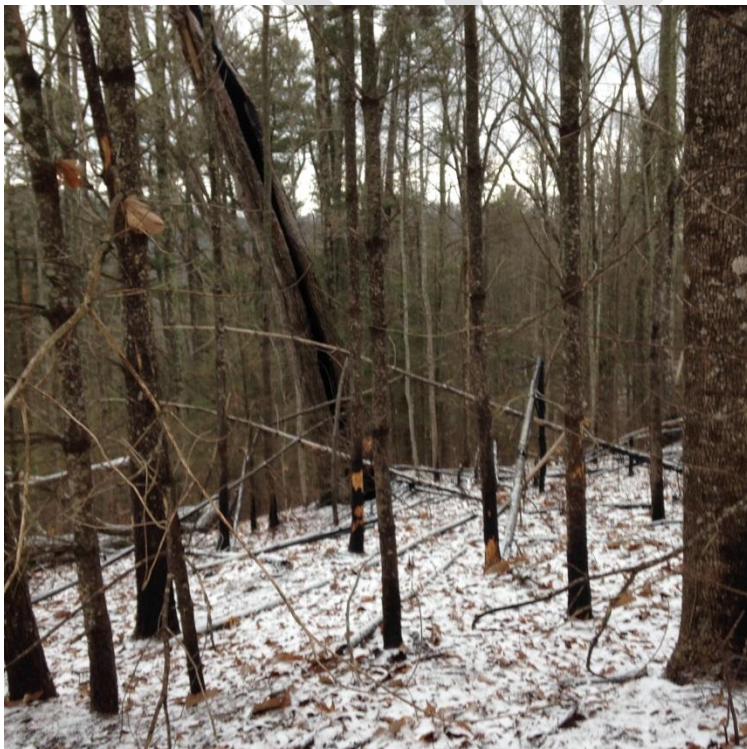
Figure 28. One of the ridges below the road proposed for commercial timber harvest. Area mapped as Junaluska-Brasstown "F".

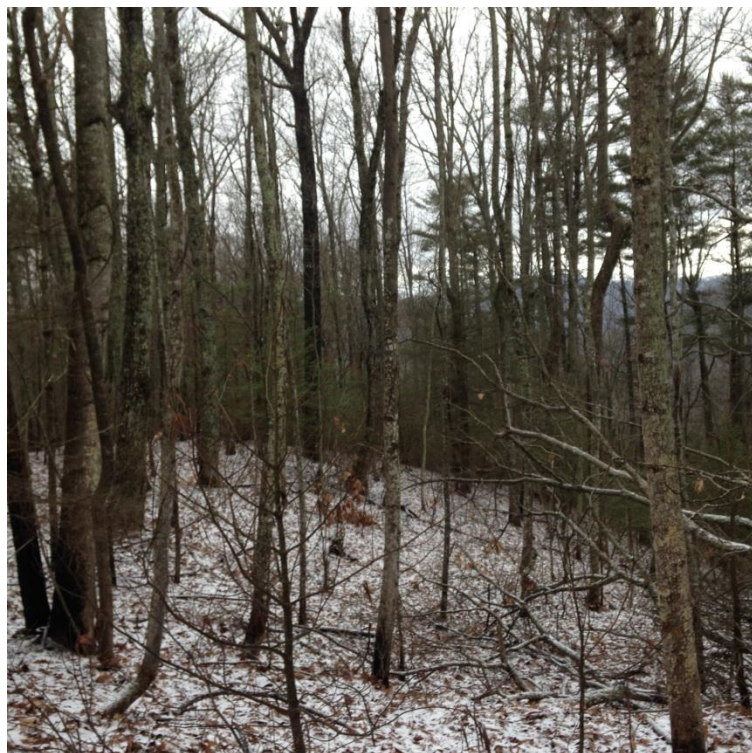
Figure 29. Looking north into northeastern portion of stand. Area mapped as Junaluska-Brasstown "D".

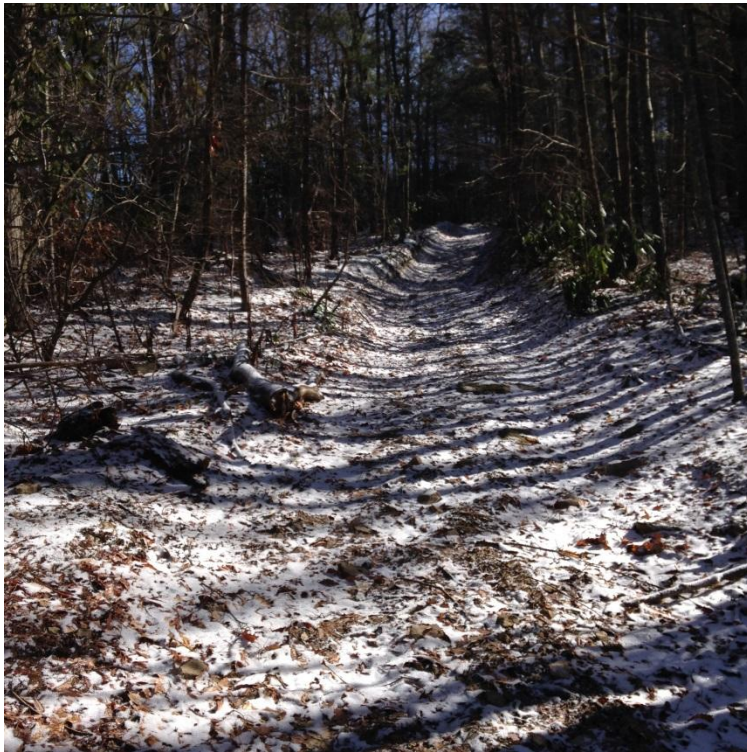
One stand, 218/10, was inspected on the fourth day of fieldwork. It should be noted that FSR 422 is in extremely poor condition between stands 217/31 and 218/10. This road segment is steep, entrenched, has inadequate drainage, and is a source of gully erosion. This portion of road is slated for decommissioning under Alternatives B, C, and D.

Figure 30. Looking south along portion of FSR 422 slated for decommissioning. Area mapped as Junaluska-Brasstown "F".

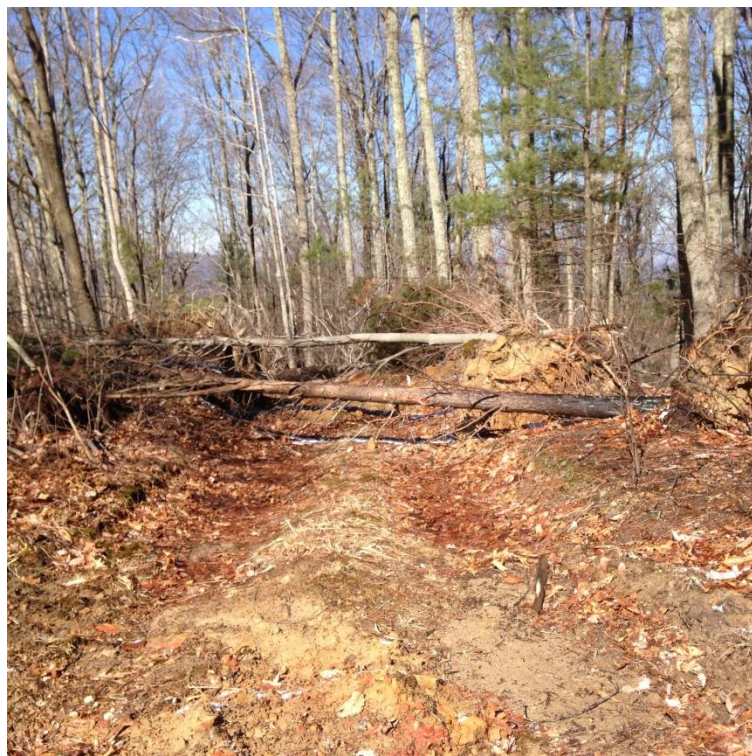
Figure 31. Looking north at southern terminus of segment of FSR 422 slated for decommissioning. The FS has felled trees in this vicinity to discourage illegal OHV use. Area mapped as Junaluska-Brasstown "E".
